## **How can a cutting-edge gallium nitride high-electron-mobility transistor encounter catastrophic failure within the acceptable temperature range**

Song, Sungyoung; Munk-Nielsen, Stig; Uhrenfeldt, Christian

*Published in:*  
I E E E Transactions on Power Electronics

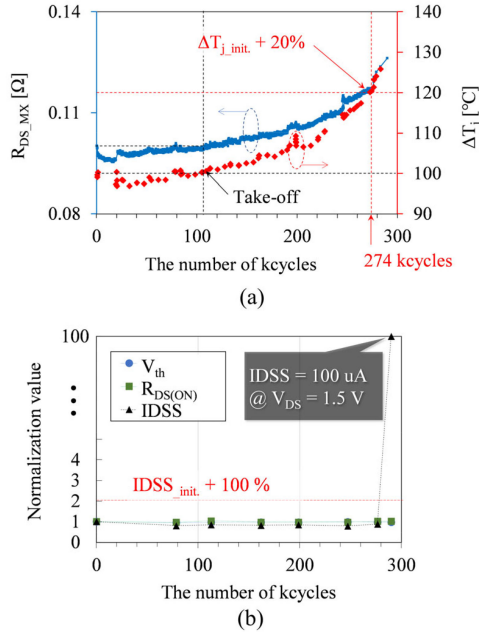
Fig. 2. Power cycling test results with  $\Delta T_{meas} = 24.1 \sim 124.1$  °C. (a) Online parameters monitored during the PC test:  $R_{DS\_MX}$  and  $\Delta T_{meas}$ . Confirmed failure mode is the initial  $T_{meas} + 20\%$ . (b) Normalized offline parameters characterized in a curve tracer at the room temperature:  $V_{th}$ ,  $R_{DS(ON)}$ , and  $IDSS$ . The failure criteria to determine the failure of the Device Under Test (DUT) are summarized in Fig. S3. The initial values of  $V_{th}$ ,  $R_{DS(ON)}$ , and  $IDSS$  are 1.3 V, 44.8 mΩ, and  $0.77 \mu A$ . Offline parameter curves and parameter definition conditions are displayed in Fig. S4.

In the result, two failure phenomena are observed; thermal conductivity degradation and IDSS failure. Fig. 2(a) and (b) exhibits two online parameters ( $R_{DS\_MX}$  and  $\Delta T_{meas}$ ) monitored in a PC circuit and offline parameters ( $V_{th}$ ,  $R_{DS(ON)}$ , and IDSS) measured by a curve tracer at the room temperature, respectively. The details of the measurement are elaborated in Fig. S2. The first failure phenomenon can be explained by the  $\Delta T_{meas}$  and  $R_{DS\_MX}$  increase after the take-off point in Fig. 2(a) and no change of  $R_{DS(ON)}$  in Fig. 2(b) [25], [26] at the end of test. In line with previous studies, the cause of this failure is the solder joint fatigue. Fig. 3(b) and (c) shows the solder joint images confirmed by scanning acoustic microscope (Model: KSI V-8 from IP Holding). In a comparison of them, it can be seen there is solder delamination underneath TPAD where the most heat is concentrated during the test. It is worth noticing, that the temperature swings employed are well within the acceptable operating conditions but still, the leakage current failure develops, which corroborates that the overheating scenario in Fig. 1 cannot explain the IDSS failure. Thus, the remaining dielectric crack hypothesis in Fig. 1 will be investigated extensively with additional structural FA.

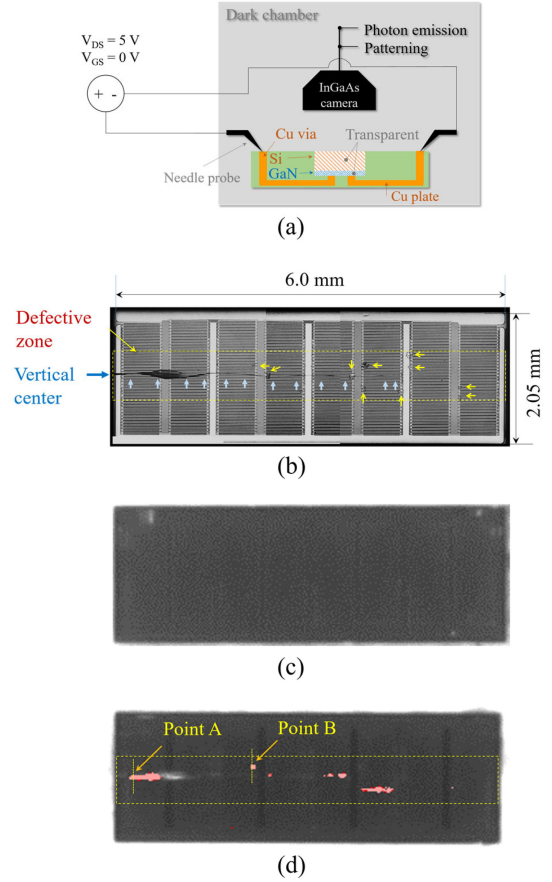
Fig. 4. Defect localization analysis. (a) Backside EMMI analysis environment with partially decapsulated GaN device. Three probe needles (gate, source, and drain) are used for electrical connection between the sample and measurement equipment. The analysis is conducted with an InGaAs camera in a dark chamber. (b) Patterning image of the failure GaN device in backside EMMI analysis with a die size, a long horizontal defect marked by blue arrows (↑), and dot-like defects marked by yellow arrows (↑). (c) Photon emission analysis of a normal GaN device without PC test under  $V_{DS} = 5 V$ , and  $V_{GS} = 0 V$ . (d) Photon emission analysis with two cross-sectional points of the failure GaN device by the PC test under  $V_{DS} = 5 V$ ,  $V_{GS} = 0 V$ .  $IDSS$  curves of both Fig. 4(c) and (d) are displayed in Fig. S7.

Fig. 4(b) shows a patterning image of the defective device analyzed in the backside EMMI. The various abnormal patterns suspected as defects are observed in this image. The abnormal patterns are classified into two types. The first conspicuous defective pattern is a long horizontal crack marked with blue arrows in Fig. 4(b). This crack at the vertical center of the GaN die is continued from the center of the die to left edge. Moreover, several of dot-like defect patterns marked with yellow arrows on Fig. 4(b) are observed around the horizontal crack. They are also placed in around the vertical center of the die. All defects

found in the patterning process are placed in the defective zone marked in Fig. 4(b). They might be directly related to the IDSS failure. The results will be argued with photon emission analysis conducted under IDSS measurement conditions.

Fig. 4(b) visualizes the defective positions directly contributing to the IDSS failure. Generally, the photon emission may occur even in normal operation so that the analysis of the defective device should be compared to a normal device without a PC test. Fig. 4(c) and (d) shows the photon emission images of the normal and the defective devices, respectively. In Fig. 4(c), there is no photon emission and  $\text{IDSS} = 0.45 \text{ nA}$  at  $V_{\text{DS}} = 5 \text{ V}$ , whereas in Fig. 4(d) (the defective device), certain photon emission and  $\text{IDSS} = 0.122 \text{ mA}$  were observed. Moreover, it is shown that the lighting positions are matched with the abnormal cracks in the patterning image [Fig. 4(b)]. The overlapping positions of the crack patterns and photon emission in these two images inform where the direct cause of the IDSS failure is. Cross-section analysis will then be performed at in Points A and B marked in Fig. 4(d) to understand the mechanism of IDSS failure in the following sections.

The locations of cracks found in the previous FA can be discussed with the FEM simulation. We can divide the cracks found in Fig. 4(b) into two groups: the long crack propagated from the center of the chip to the left edge and dot-type cracks scattered around the center. For the long crack, first we can inversely predict there was a strong vertical mechanical stress in the PC test. Fig. 7(a) shows the distribution of temperature swings at the die top surface height during PC. The different temperature distribution by the area of a homogeneous body can generate mechanical stress [45]. In Fig. 7(a), the center of the die has the highest temperature swing, while the upper left end has the lowest temperature swing. This imbalance can produce the overall thermomechanical stress of the die during the PC test. The Cu vias are not symmetrical at the left and right edges of the die in Fig. 7(b), which leads to a temperature imbalance between the upper and bottom at the edges of both sides. This imbalance induces stress on the surface of the die, which can lead to defects such as the first long crack.

The second crack group dot type defects in Fig. 4(b) can be analyzed by combining the EMMI patterning image [Fig. 4(b)],

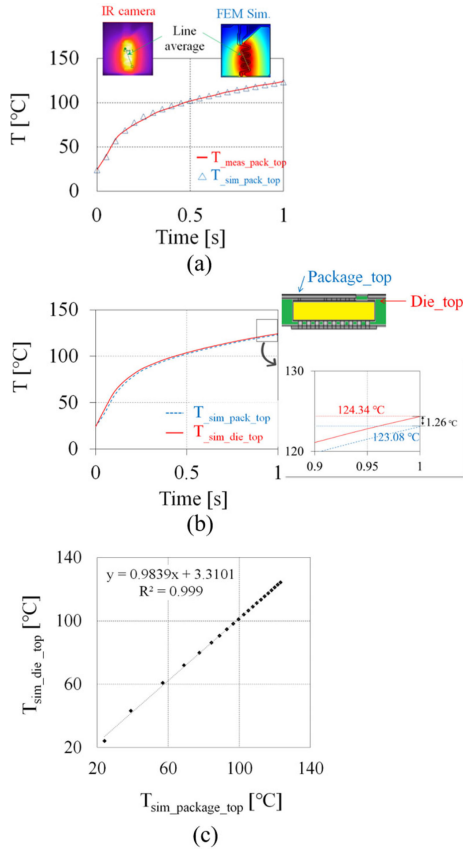
Fig. 6. Temperature analysis in a PC test based on FEM simulation (COMSOL Multiphysics software). (a) Line temperature average curve during 1 s heating period between IR camera measurement of the DUT and FEM simulation on the top surface of the package. (b) Temperature profile comparison in FEM simulation between package top surface and die top surface. (c) Correlation of temperatures between on the package top surface and on the package top surface. The temperatures mentioned Fig. 6(a) and (b) are equally defined as the average value of a line across the upper left to lower right of the die on the top surface of the package, which is the same as the way to monitor device temperature in the PC test [26, 27]. The lines for temperature measurement are shown in Fig. 6(a).

It is critical in simulation to find the heat flux condition that accurately reflects the experimental environment. For this, we first measured the temperature of the device at specific power consumption in a PC test environment and then derived heat boundary condition satisfying the temperatures corresponding to the power consumption conditions in the simulation. In the PC test environment, two temperatures  $23.8\ ^\circ\text{C}$  and  $25.8\ ^\circ\text{C}$  were measured under the two static power dissipation levels of 1.099 and 1.653 W, respectively. Through the FEM simulations, the heat flux condition  $1.55 \times 10^4\ \text{W}/(\text{m}^2\cdot^\circ\text{C})$  satisfying the two results measure earlier had been extracted. The condition can be reverified in transient temperature comparison between the simulation and the real PC test. Fig. 6(a) displays the temperature ( $T_{\text{maes\_pack\_top}}$ ) measured on the package top surface in the test and the temperature ( $T_{\text{sim\_pack\_top}}$ ) on the package top surface in the simulation. As can be seen they have a very good quantitative agreement between both temperature curves in Fig. 6(a). Moreover, we compared the thermal spatial spreading in the simulation to the real PC test during a single PC recorded as a movie using a thermal camera monitoring the device surface this is supplied as supplementary video. In this comparison, the model parameter fitted was the heat boundary condition based on the simpler steady-state conditions, while we were able to confirm that this simulation is very close to the actual test result in terms of dynamic predictions. The proposed simulation, therefore, is confirmed to be very close to the real operation not only in constant condition but also in a transient condition, which ensure the credibility of this simulation.

The measured temperature is the most direct stress parameter that we can monitor during the PC test. For this reason, the smaller the difference between this temperature and the actual junction temperature, the better. In the device using a no wire bond package, the difference between the junction temperature and the temperature measured by an IR camera has not been addressed for transient conditions in previous literature. Fig. 6(b) shows a difference of temperature on the top surface of between  $T_{\text{sim\_pack\_top}}$  and on the die ( $T_{\text{sim\_die\_top}}$ ) in the FEM simulation during a heating period 1 s of the PC test. Both temperatures were also defined as the average value of the line at the same position shown in Fig. 6(a). The change trends of them are very similar to each other, and the maximum temperature difference at the end of the period is only 1.26 °C.  $T_{\text{sim\_die\_top}}$  represents the junction temperature in the simulation. Fig. 6(c) exhibits a strong correlation of both temperatures in the simulation. We can understand the temperature measured on a package top surface accurately reflects the junction temperature with a slight minus offset, indirectly through the simulation.

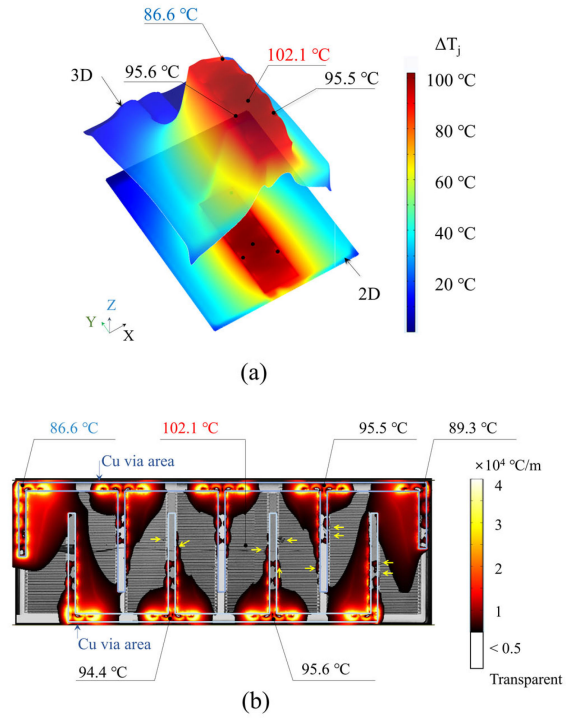
Fig. 7. FEM simulation analysis with defective patterns in the EMMI analysis. (a) 2-D and 3-D  $\Delta T_{\text{die\_sim}}$  distribution of the entire GaN device at the height of die top surface in FEM simulation during the PC. (b) Overlap image among the EMMI patterning image [Fig. 4(b)], Cu via areas directly bonded to the die,  $T_{\text{die\_sim}}$  at 1 s in six points and  $T_{\text{die\_sim}}$  gradient (°C/m) plot in the die top surface area.

the knowledge of the Cu via design inside the package directly bonded to the die, and the temperature gradient of the die ( $T_{\text{die\_sim\_grad}}$ ) extracted from the FEM simulation at the highest point during a PC. Fig. 7(b) exhibits an overlap image of these three items.  $T_{\text{die\_sim\_grad}}$  is expressed as (1).

When referring to Figs. S9 and S10, it is seen that the temperature gradient on the die top surface is significantly influenced by the Cu structure inside the package. Particularly,  $T_{\text{die\_sim\_grad}}$  is relatively high along the Cu vias in the center of the die surface. There might be a larger temperature gradient around the boundary between them because Cu has much better heat transfer capability than FR4 which is filling most of the package [38]. In Fig. 7(b), the cracks pointed by the yellow arrows are located mainly near the Cu vias within the center area of the die. In this area, it is expected that severe mechanical stress is generated by CTE differences among the materials (Cu, FR4, a GaN die) at these interfaces as well as the larger temperature gradient. Thus, it is revealed that the dot-type defects also correlate with the Cu vias design in the package.
